Instituto Politécnico de Setúbal

Mestrado em Segurança e Higiene no Trabalho Projecto Final

Melhoria na Segurança e Higiene no Trabalho Após a Certificação Numa Multinacional

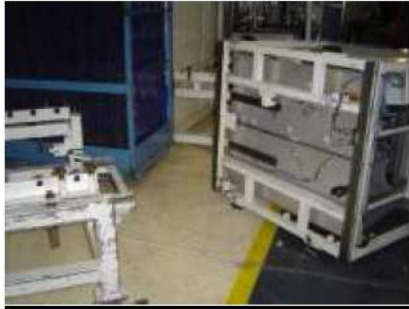
<p> Date: 18-09-2007 Time: 08:20 PM Estimated lost days: 5 days Estimated Date of Return: Week 29. Cause: Potential Serious Accident [Safety / Ergonomic / Motivation / Occupational Disease] </p> <p> Description of Work Performed: Manual mould unload operation. The foreman was changing the mould from a welding machine. Operation: 1-approach the trolley to the machine, 2-block wheels, 3-charge the mould on the trolley (sliding on metallic cylinders), 4-lock the mould on the trolley, 5-unblock wheels, 6-move the block to the store area. There are two safety devices to block the mould on the trolley: An automatic system (that can fail, depending on the mould) and a manual system. <i>Note: This manual lock-out was implemented after a previous incident investigated in February.</i> </p> <p> Description of Incident: The worker didn't lock the mould with the manual device (phase 4). When he performed phase 6, the mould slipped and fall down, hitting his face. </p> <p> The trolley was in bad conditions (no manual safety device in place), it seems that was know by Production and Maintenance. </p> <p> Injuries: Contusion in different parts in the face and left shoulder. The face wound needed some stitches. </p>	<p>Photo1</p>

<p>Key Point Summary</p> <ul style="list-style-type: none"> ➤ Lack of zero tolerance and proactivity: the unsafe condition didn't cause any reaction ➤ Defective-unsafe equipment ➤ Unsafe action, using defective equipment ➤ Inadequate-unsafe design (the automatic lock is not reliable) 	<p>Key Learning Points</p> <ul style="list-style-type: none"> ➤ Unsafe equipments must be put "Out of service" as soon as know. ➤ If somebody knows the unsafe condition, he shouldn't use the machine. ➤ Unsafe conditions must be communicated to every affected department as soon as know

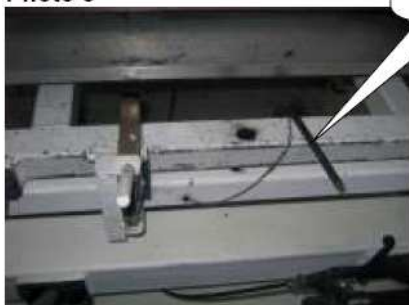
<p>Automatic mould lock</p>

<p>Manual mould lock system</p> <p>Photo 3</p>

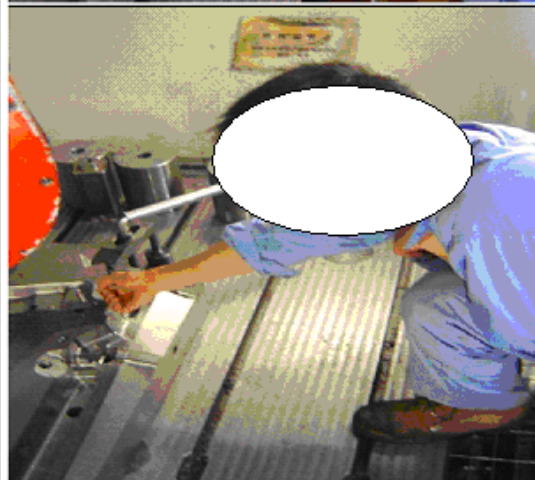
Photo:

The back of the middle finger was injured.
The employee was diagnosed that the back of the middle finger was injured by metal(1 cm long), the parenchyma was also injured, the bone was not injured.
The employee failed to report the incident immediately and went to the doctor the next day.

There was some oil on the tools which caused his hand to slip.
He didn't observe the surrounding dangers (oil on the tools) and take the necessary measures to avoid the incident.
Overexerting is the main cause.

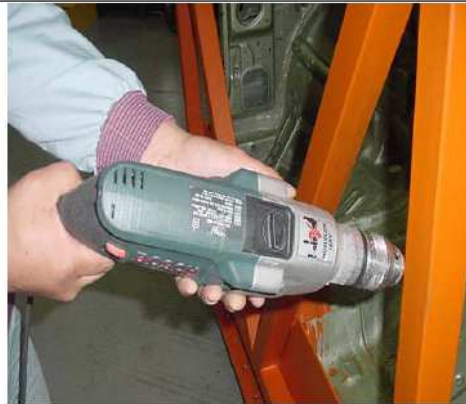
At 11:10 Aug 28th 2007,
Fitting a hole with a high speed drill which is overlapped
on two steel plates in test room, a worker's right hand
slipped off and hit a steel pipe due to its rotatory power
on the plate. So he fractured his finger on right hand.

Fracture of the ring finger on the right hand.

- -Preventive Actions
- -Feedback to the employee of similar operation.
- -Installed support-bar
- -Use a table drill for big hole

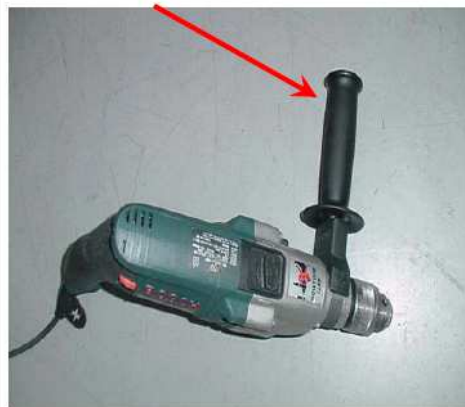
Installed support bar on drill

- Conduct refresh training regarding proper drilling procedures
- Job instructions to be clearly posted
- Be able to identify defective equipment/improper use of equipment in the future
